Rail Accident Report

Head-on collision between a passenger train and a freight train
in Tempi, 28 February 2023

RL01-2025, 27 February 2025

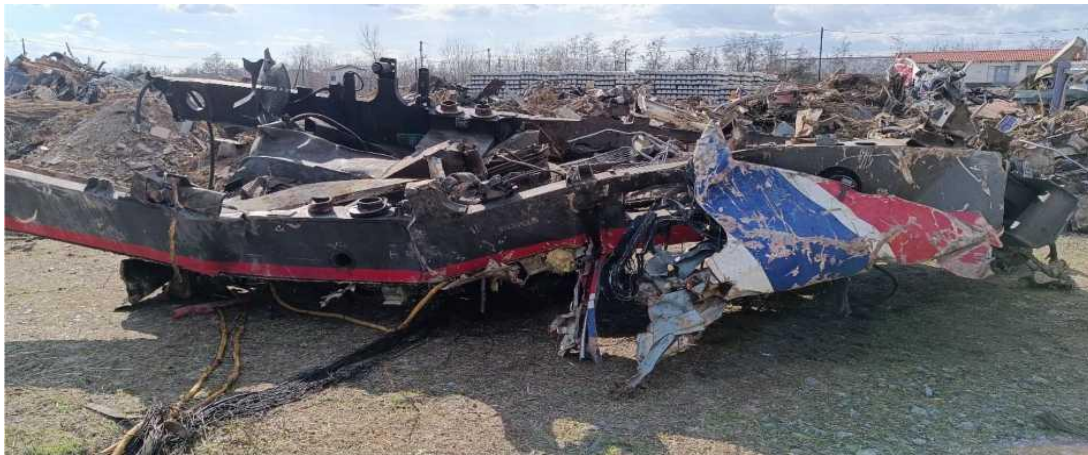
Figure 17. Part (chassis) of the completely destroyed locomotive 120-023 of the passenger train IC-62.

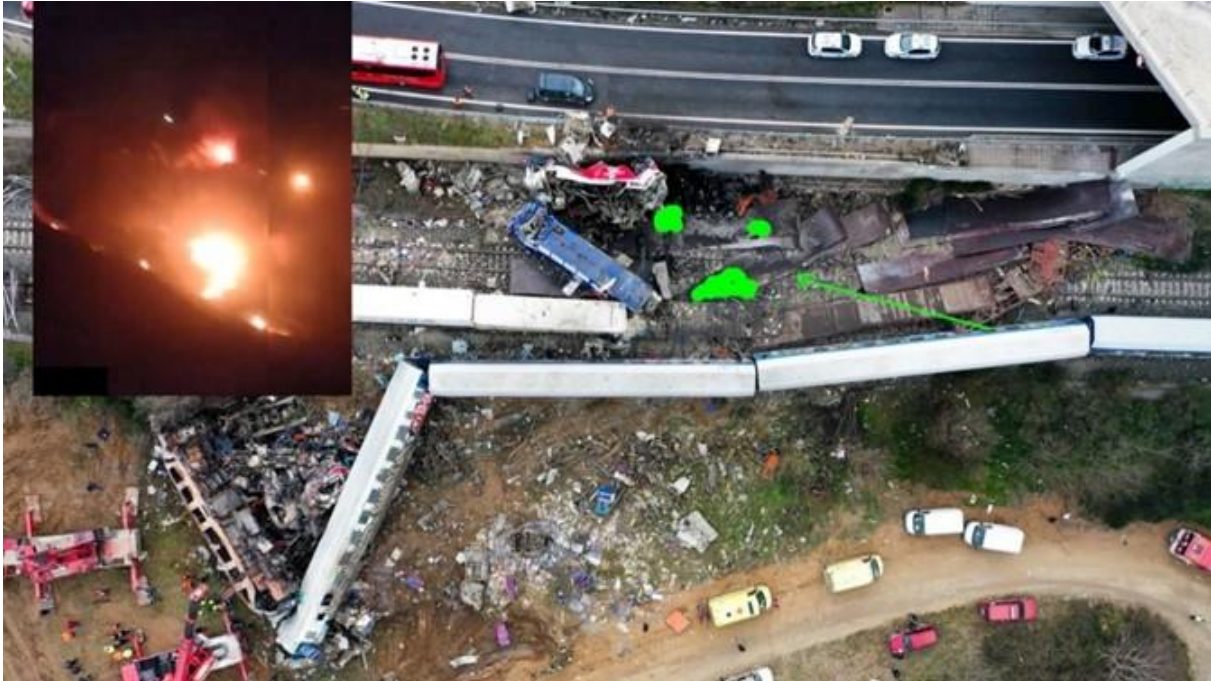
Figure 64. Fire inside the transformer of freight train as a secondary result of pool fire #1.

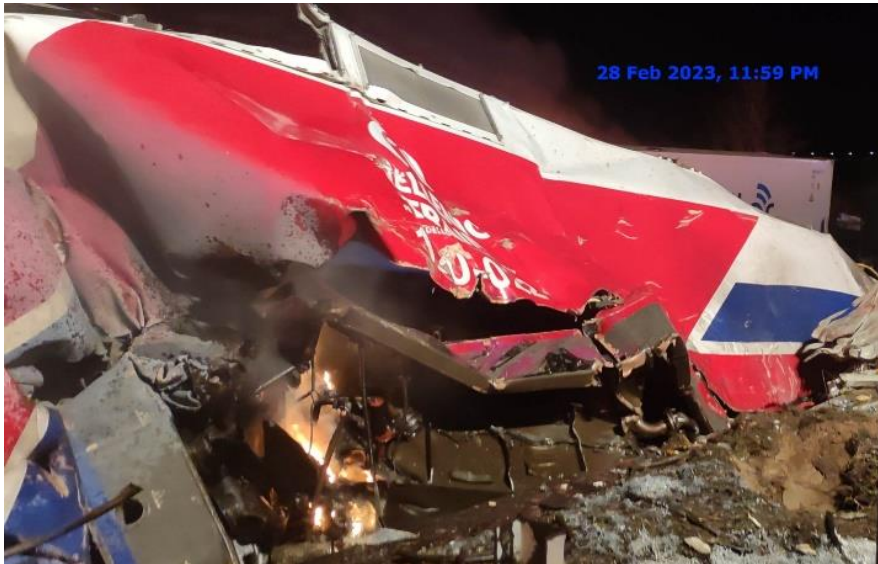
Figure 65. A local fire inside and outside the broken transformer of the first locomotive of the freight train, 40 minutes after the accident.

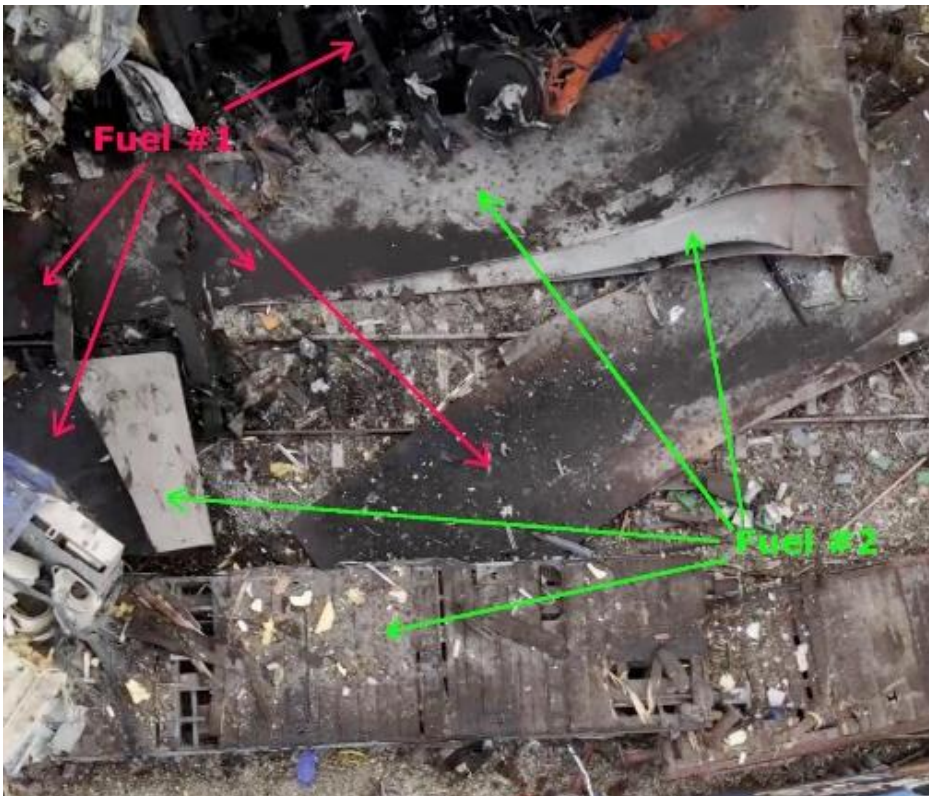
Figure 66. Evidence of two different fuels burning in the pool fire #1, one leaving black, the other leaving white residue.

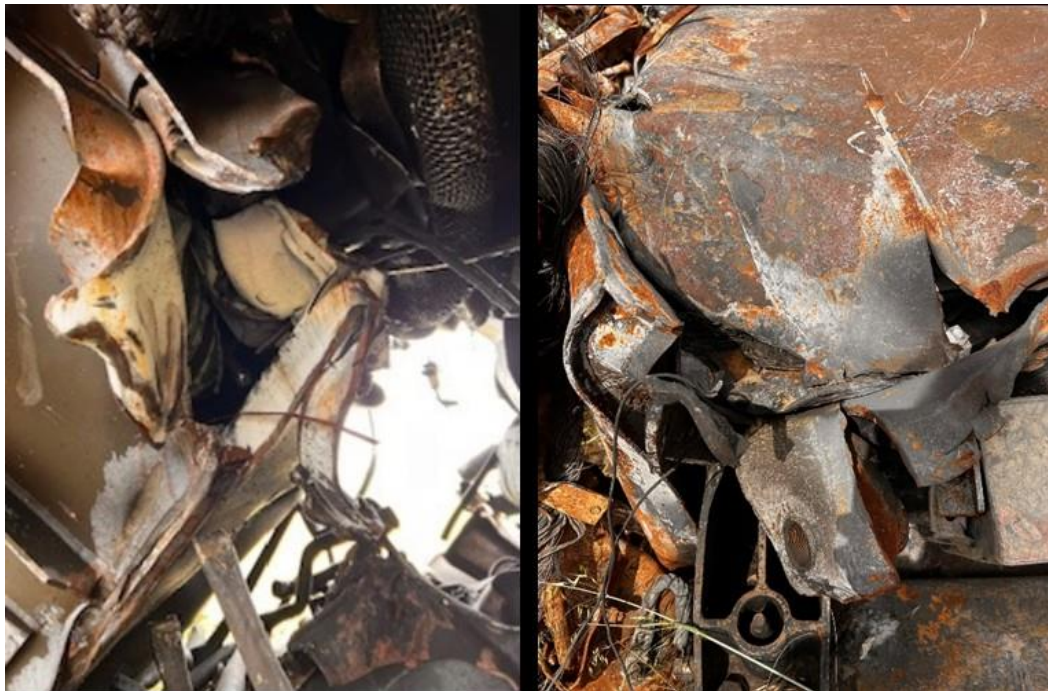
Figure 67. Large cracks of the transformer still attached under the 120-022 locomotive (Left). Bumps, folds, rips and large cracks of remaining locomotive transformer 120-023 (right), see also Figure 61.

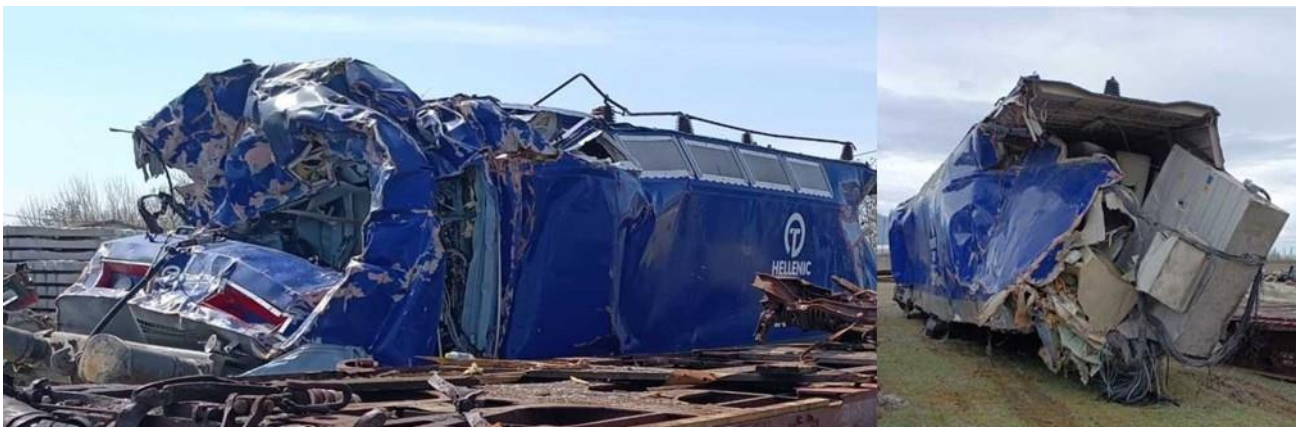
Figure 78. Position 2) 120 012 locomotive, heavy damage in the front (with locomotive 120-022) and rear, signs of crash against 1st container on P4, without the missing rear cab.

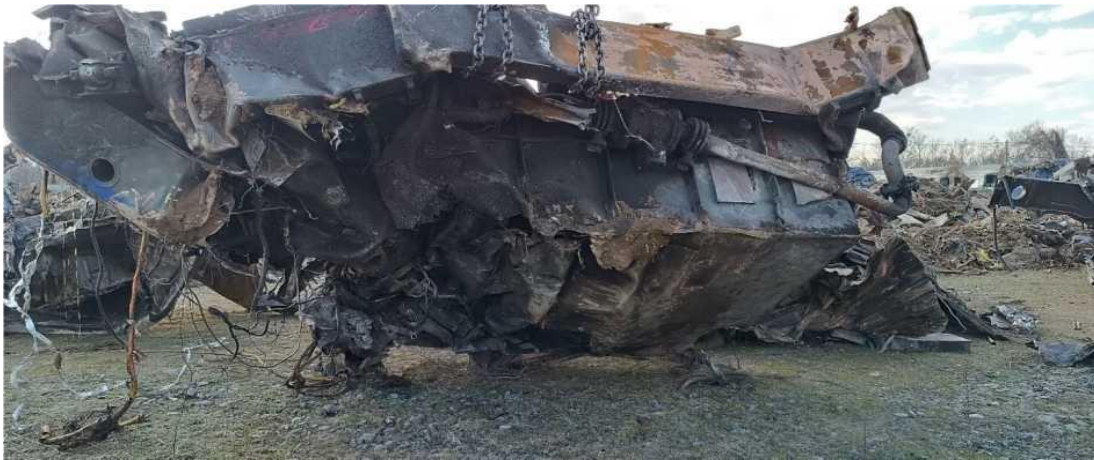
Figure 85. Position 1) 120 023 locomotive, totally destroyed, broken into large pieces. Remaining piece of the basement platform. Part with transformer still visible. Other side in Figure 17. At the position 2) the A1 1st class coach, totally destroyed, has broken into small pieces, and was not recognisable as a whole vehicle.

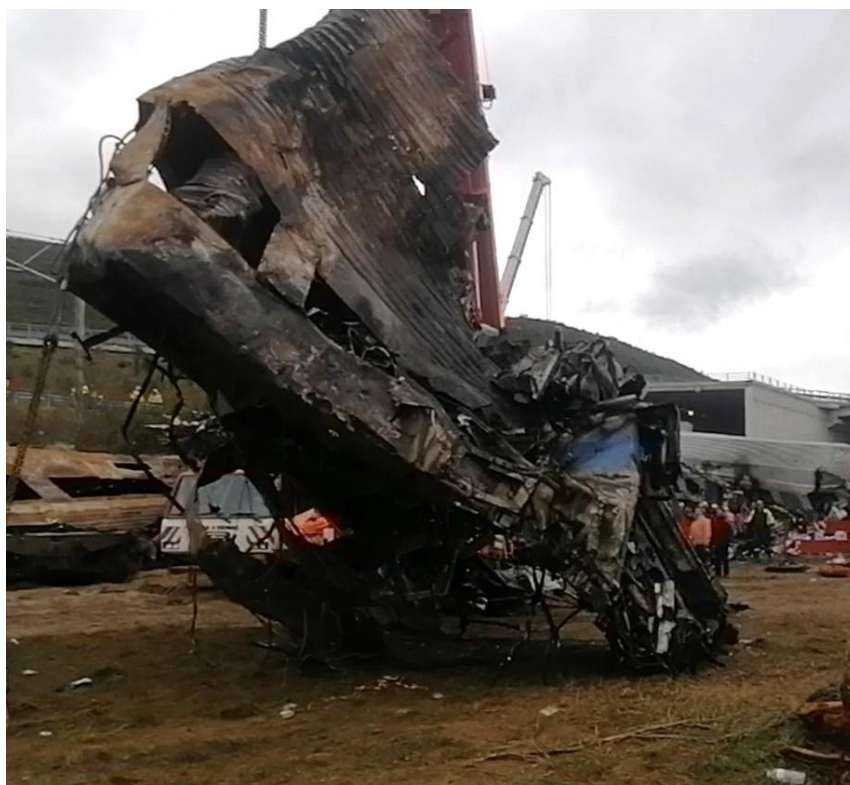
Figure 86. Position 3) Restaurant Car, very heavily damaged from initial crash (folded, bent into S-shape) and burned down. Here, suspended from the crane cables.

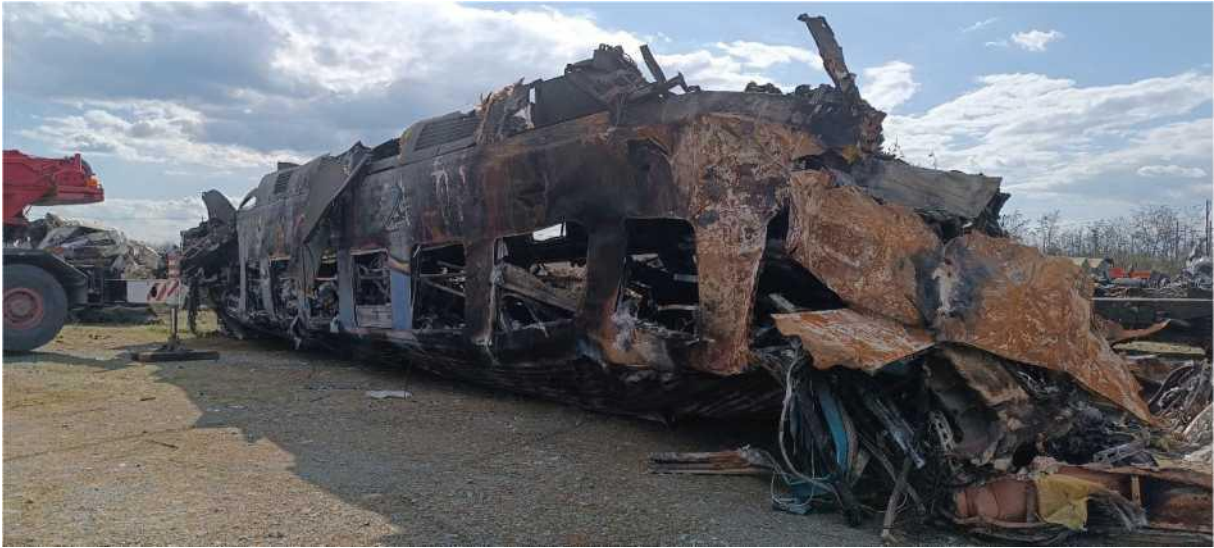
Figure 87. Position 4) B2 2nd class coach, heavy impact damage in the front and rear, fire slowly consumed it.

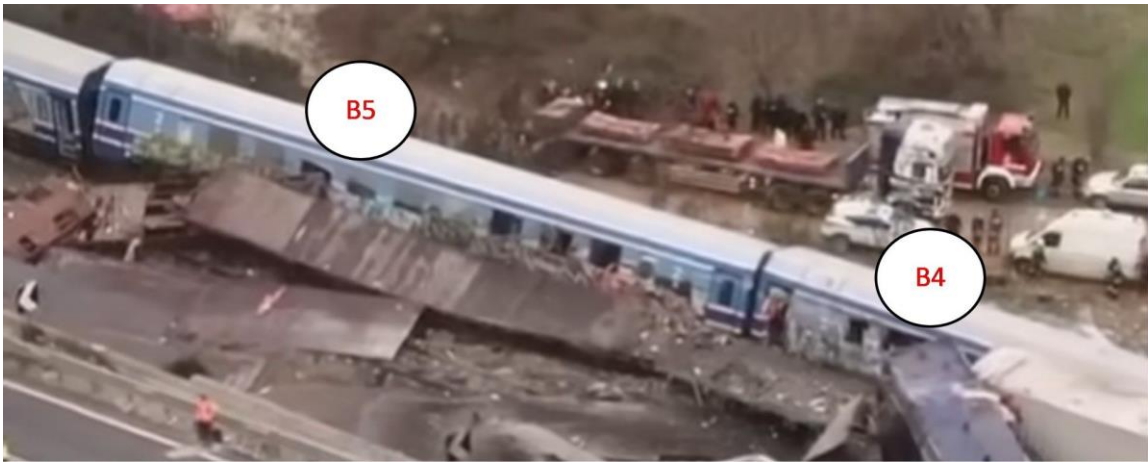
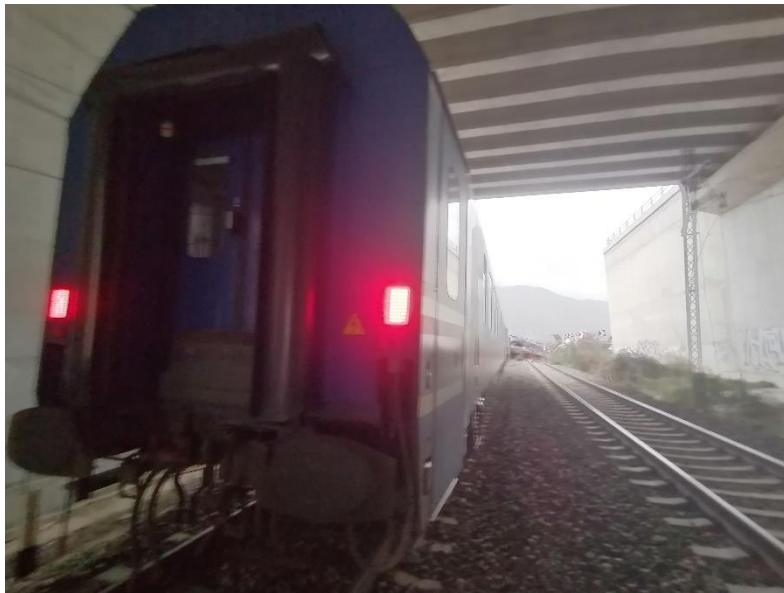
Figure 89. Positions 6-9) B4-B7 coaches, B4 and B5 derailed and were hit on the side by steel plates, B6 and B7 did not derail, no damage, B7 remained nearly all in the tunnel.
