Rail Accident Report

Head-on collision between a passenger train and a freight train
in Tempi, 28 February 2023

RL01-2025, 27 February 2025

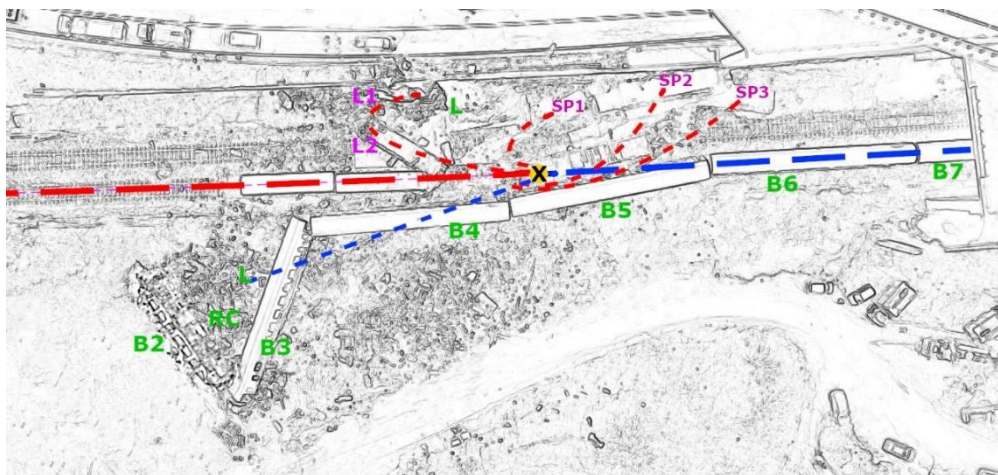
- 130 The 1st phase mainly involved the first 4 vehicles of the two trains: 2 locomotives 120-022 (first) and 120-012 (second) of the freight train and the locomotive 120-023 with its first-class A1 coach. The initial impact is a head-on collision between passenger train locomotive 120-023 and the first freight train locomotive 120-022, that causes the latter, along with the second locomotive 120-012 to be catapulted towards their left over the upward line track and smashed against the motorway wall, with the second locomotive making a U-turn and its rear end sliding over the steel plates carried on the 3rd platform of the freight train to come to a standstill with its front side against the first locomotive and its rear end resting against the first shipping container carried on top of the 4th platform of the freight train (Figure 10, Figure 11, Figure 12).

Figure 11. Global movement of the collision, with the initial impact and catapult effects. (SP1,2,3 are Steel Plates, and were also catapulted)

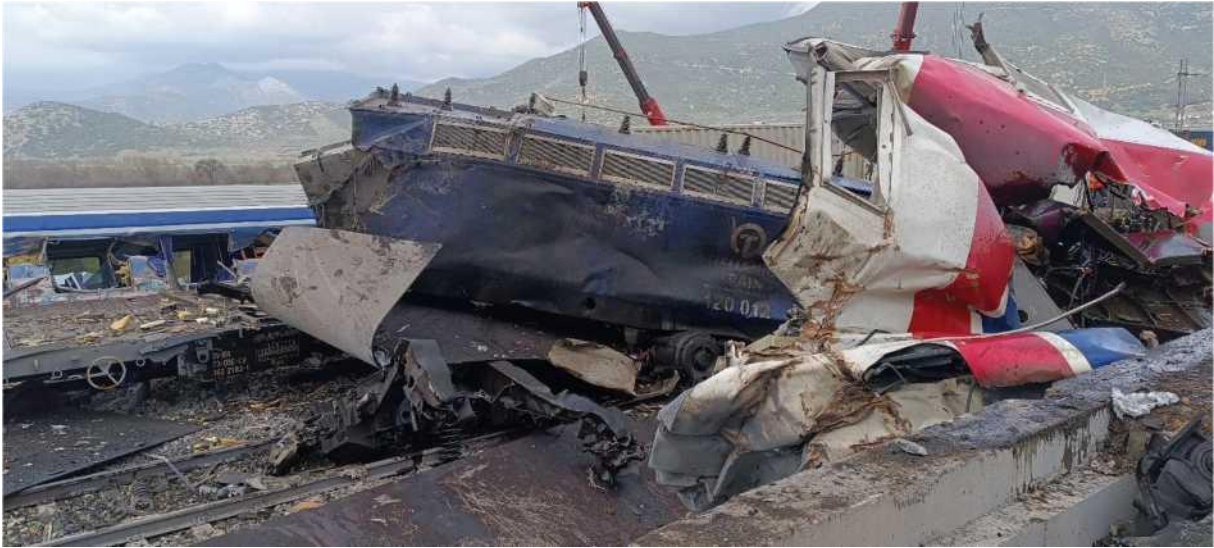
Figure 13. Locomotives 120-022 and 120-012 of the freight train 63503 after the accident. Front view, from the road.

138 By comparing the damage to the steel plates and the Restaurant Car, it can be considered as most likely that the initial impact to the Restaurant Car came not on its front bumper but underneath its “belly”, indicating that the Restaurant Car had a slightly “nose-up” attitude at the moment of the impact, which is consistent with the damage observed on the first and presumably topmost steel plate that was found wedged underneath the blue 120-012 locomotive. Meanwhile, the 1st platform of the freight train sustains very heavy damage from the impact with the Restaurant Car that leaves it bent in half and wedged under the remaining steel plates against the wall, and spread few meters after the collision, in the area before the entrance of the tunnel. (Figure 13, Figure 22).

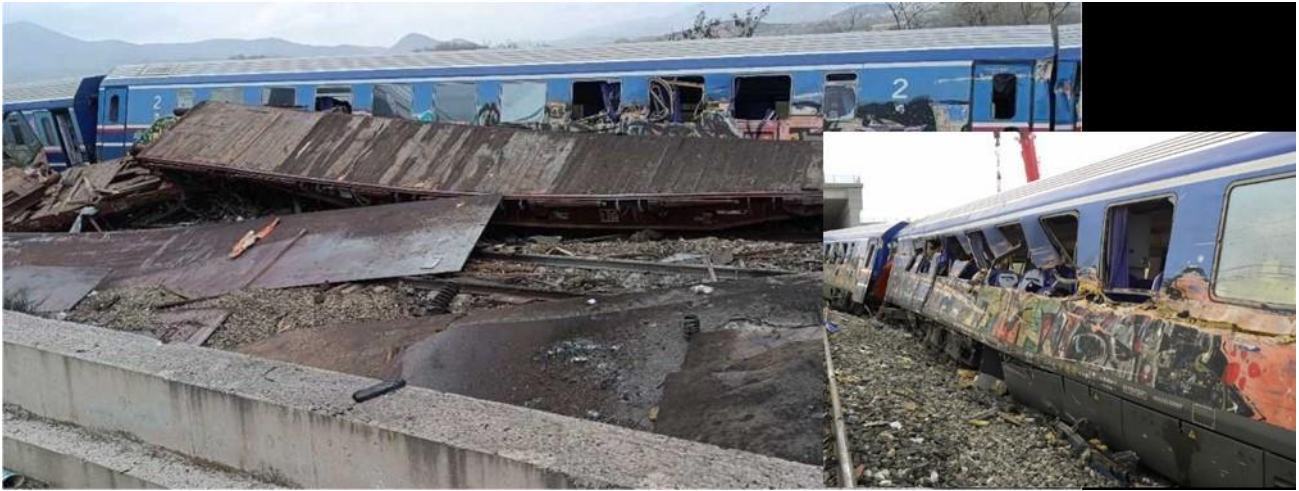
- 143 Meanwhile, the remaining 12 vehicles of freight train 63503 and the remaining 4 vehicles of IC-62 continue their last part of their forward movement, where in addition to braking action there is also side impact between the steel plates and the sides of the 2nd and 3rd platform and the sides of the B3, B4 and B5 coaches of the passenger train (Figure 25).

Figure 25. Linear impact of steel plates on the side of the coach B4.

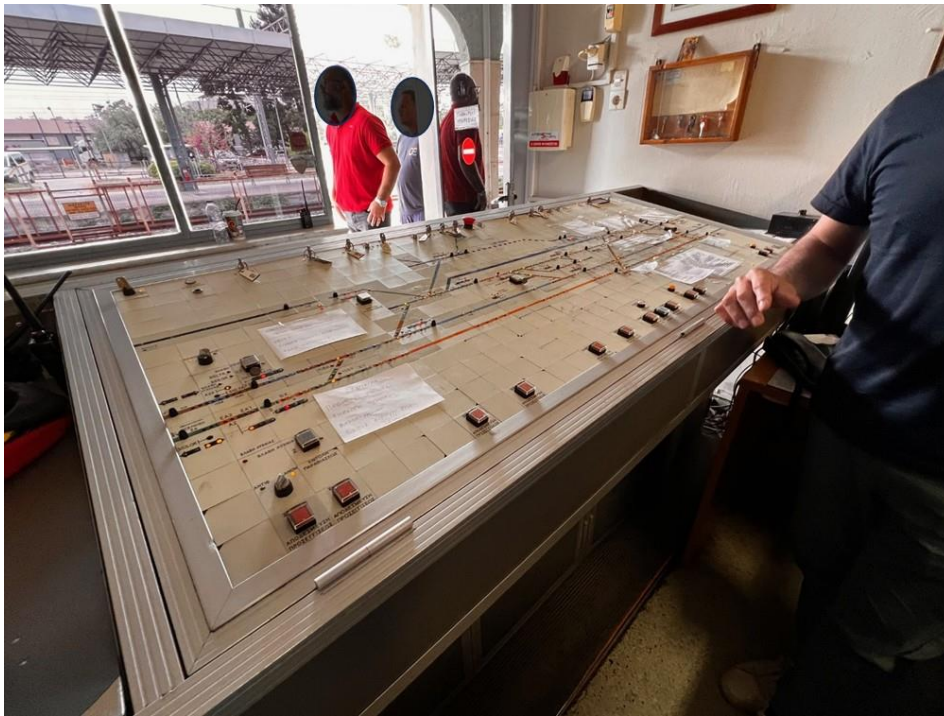
Figure 37. The control panel at Larissa Station

- 189 As it can be observed on the global photo of the control panel (Figure 37), it is a large area with many information and commands that cannot be considered at a glance. To pass from one mode to the other (manual mode to or from automated mode), the station masters must turn a numbered key (the number refers the number of the switch) on the top of the control panel (Figure 46), separately for each switch. The area where to read the switches numbers is small and partially hidden by the plastic and metal key rings (this point is further analysed in the chapter 4.2.2). In the actual practice of using these keys, as it has been explained and shown on site, at least two ways of manipulating them co-exist, one of them being indicative of lack of trust in the system and/or lack of experience (4.2.1.3).

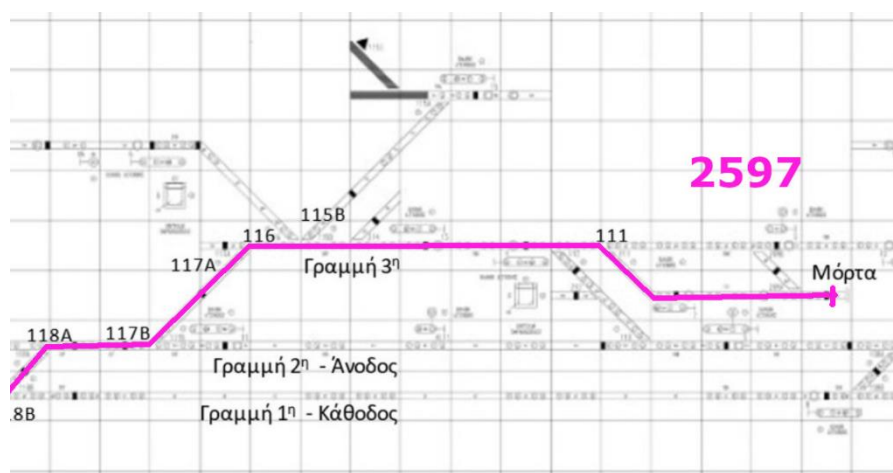
Figure 45. The route for the entry of train 2597.

- 222 Approximately around 22:35, after having received a call from the train driver of train 2597 that he was approaching the station, the station master of Larissa manually set the route with the intention for train 2597 to enter Larissa station from the north and be guided to the dead-end track between tracks 2 and 3.
- 223 This would require the setting of switches 118A/B, 117 A/B, 116, 115B and 111 to be turned in the adequate position (Figure 45). Note that this is also the action that directed switches 118 in the bypass position. Before that, these switches were turned in the straightforward position at 22:12 for the entry of train IC-63. From the recorded actions on the control panel, it can be seen that this was the last time before the departure of train IC-62 that the switches 118 were manipulated through automatic route setting.

When manually setting the route for the entry of train 2597, the station master of Larissa forgot to turn the switches 116 and 115B in the correct position. On other occasions these switches would have been in the right position after the entry and acceptance of train 2575 from Volos on track 3. Earlier in the evening, on the 28/02 this train 2575 was positioned on track 6 at 22:10 by the station master of the afternoon shift because track 3 was occupied with train 2594 that had been brought back to the station at 21:30 after traction problems arose on its way to Neoi Poroi (93).

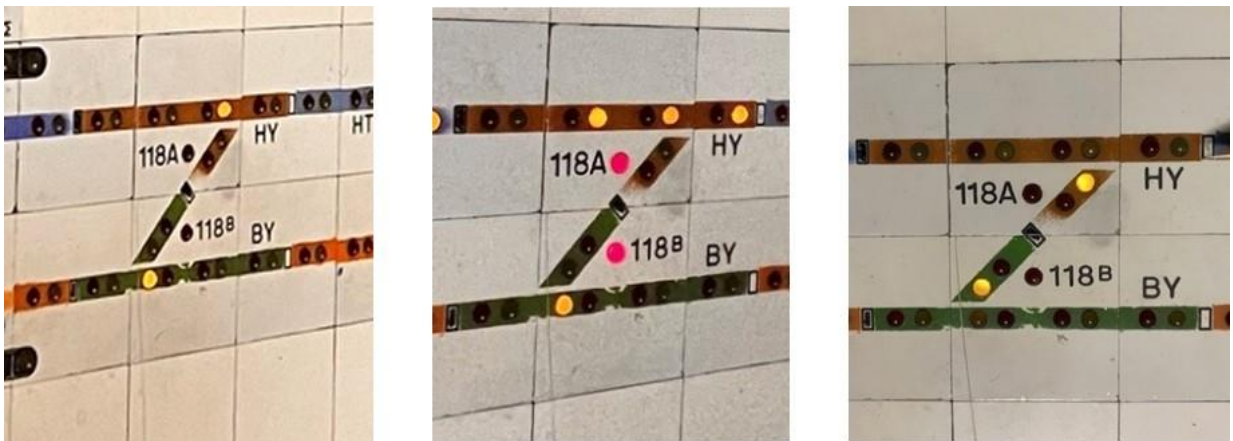
Figure 47. Detail of the switches 118 on the Larissa Control Panel (main-moving-bypass).

237 Switches are indicated on the Control Panel by the intersection of the lines showing the railway lines. Each switch is marked with a number and a letter if two switches have the same number. There are two yellow lights that indicate the position of the switch position in "main" or "bypass"(Figure 47). By setting the route, the lights in the area of the switches light up, as a combination of the light at the entrance of the switch and either the "main" or "bypass" path.

- 243 The indications on the position of switched 118 are small indications, on two distinct positions, on a larger Control Panel (the information of the Figure 47 among the ones from the whole Figure 37).

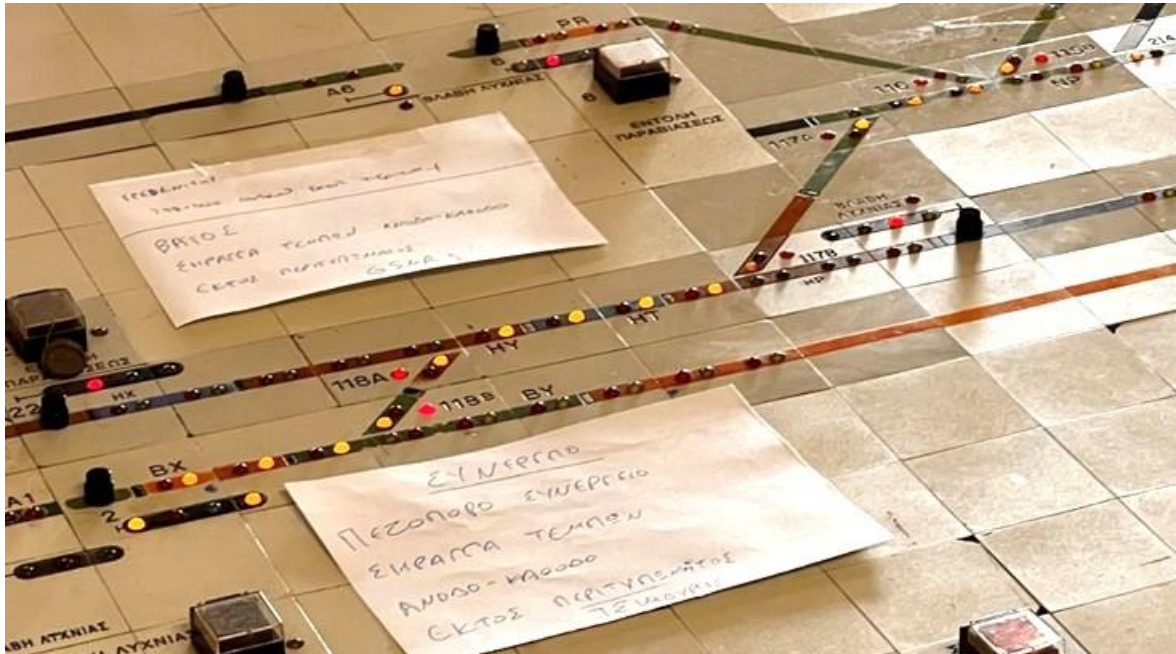
Figure 48. Detail of the Larissa Control Panel with a route set to cross a switch in a bypass position.

238 Lines on which the presence of a train is detected by track circuits or axle counters are displayed on the Control Panel in a sequence of colours delimiting the track circuit or the area controlled by each axle counter. The main lines use a sequence of colours orange/green for the ascending and blue/brown for the descending tracks (Figure 48). Within the coloured lines representing detection circuits photodiodes are placed that light up to give information to the panel operator. Lighting the yellow light on a track circuit means that a train has been "routed" to cross the section of line which is bright. The yellow light remain bright until the train reaches the circuit, when they are switched off and replaced by a group of red lights, which means that there is a train in the specific detection circuit.

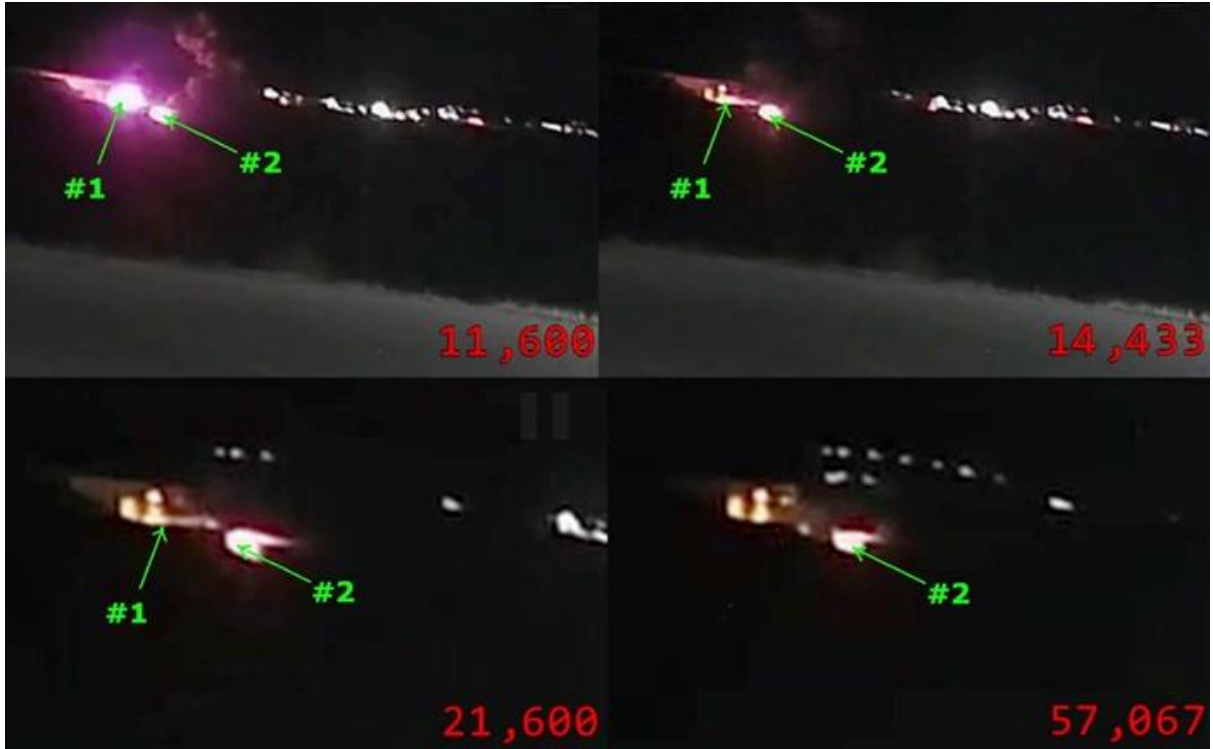
463 By following this fire backwards in time, it is most likely that the fire that consumed the Restaurant Car is the same fire that has been recorded 4 minutes after the crash, burning from the bottom of the (crashed and bent in an S-shape) Restaurant Car (color yellow added). This is also the same fire that is observed from the "Maliakos-Kleidi" camera (Fig. Y), as an uninterrupted continuous movement from the fire plume (stage 2) to pool fire #2 (stage 3).

Figure 62. Fire plume moving into pool fire #2, as observed by the "Maliakos-Kleidi" camera.

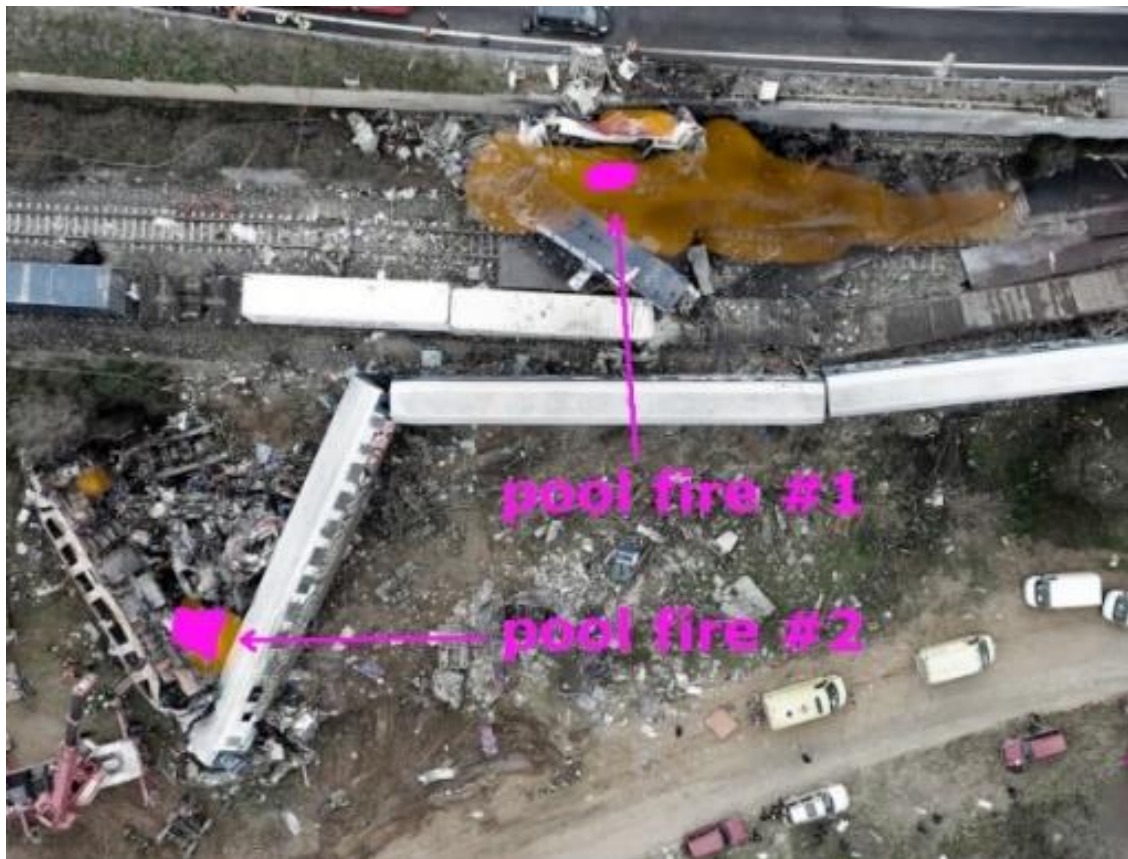
464 The two pool fires can be observed burning up any remaining fuel that was not consumed in the fireball. By comparing the geometry of the nighttime frames of video to the daylight images, it is confirmed that the two pool fires are located where fire evidence were found in the morning.

Figure 63. Location and approximate size of pool fires #1 and #2.

- 465 When following the logic of these observations, it is highly unlikely that the locomotive and its transformer filled with silicone oil played a primary role in the stage 2 fire plume and stage 3 pool fire #2.

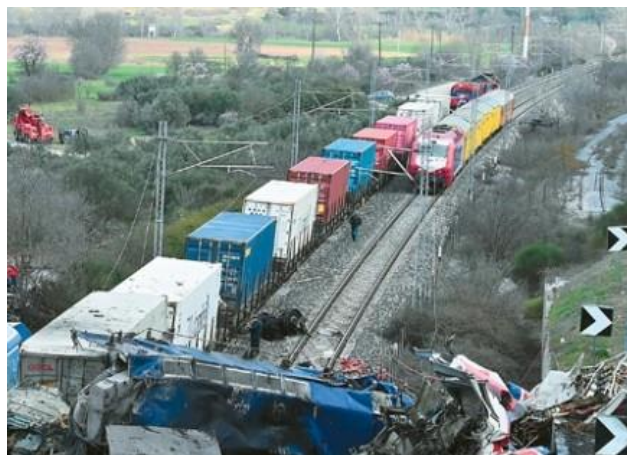
Figure 84. Positions 8)-15) The remaining platforms carrying 8 containers, undamaged and still sealed (or remained empty, of the 2 last ones), not derailed, stopped along the line and were driven away normally.
